The Refurbishment of 55 St Andrews Place, Melbourne: Turning a sparrow into a peacock

By David Clark, Partner, Cundall

This article describes the upgrade of an existing government building, 55 St Andrews Place in Melbourne's Treasury Reserve, utilising an unconventional design process and with a strong emphasis on integrated design from the outset.

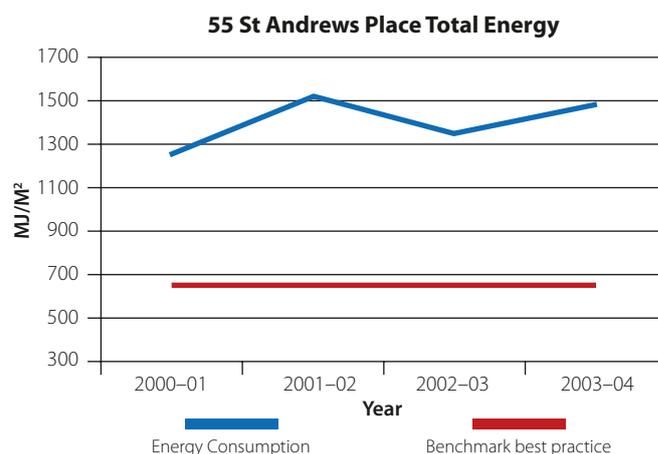
The energy use in the building was high – the total electricity and gas use exceeded best practice for this type of building and it was one of the government office portfolio's worst performers. The building rated about 1 star in an unofficial Green Star rating (one third of the building's points were due to its proximity to Parliament railway station) and would have achieved around a 1 star rating using the ABGR (now NABERS Energy) Whole of Building rating tool.

Figure 4: Historical electricity and gas consumption compared to a benchmark of 'best practice' from the Property Council of Australia Energy Guidelines 2003.

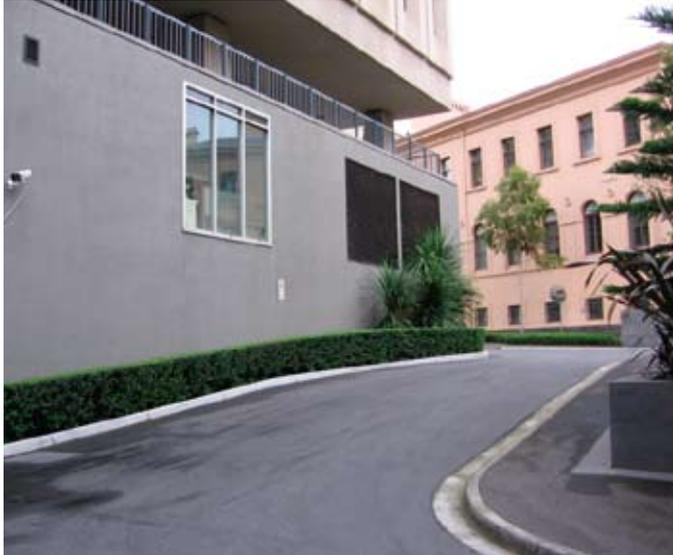
- The heavily tinted glazing became very hot in summer causing localised discomfort due to radiant heat, and cracking of the glazing in a number of windows.
- The outside air intake location resulted in it collecting exhaust fumes from vehicles in the adjacent service road (causing more than one evacuation of the building in the past!)
- The top floor roof added in 1997 was not well insulated and thus air returning to the plant via the ceiling plenum from the level 4 office space reached 40 to 50°C on extreme days, when ideally this would be around 27°C!
- The addition of VAV boxes to air-condition the additional level 4 drew air from the main Air Handling Unit, reducing the supply air to the other levels. The VAV boxes also ran backwards if started before the main system.

Figure 5: Original outside air grille to main AHU behind and original window to lower ground floor stair well.

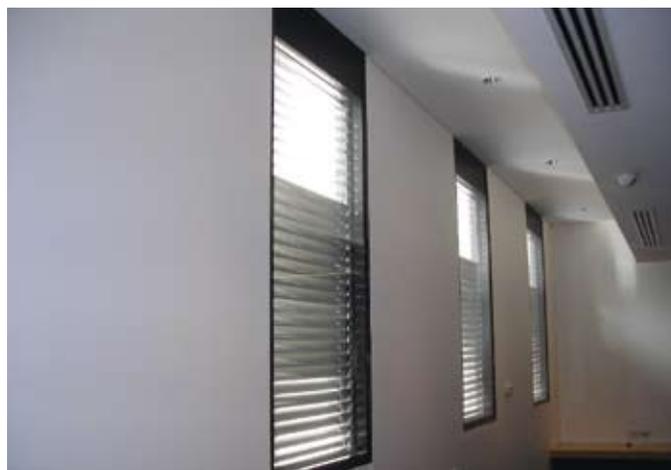
Figure 7: Refitted windows on Level 3 – clear glass and external automated daylight guidance blinds.

To increase the daylight potential, improve comfort and reduce air conditioning loads, the punched window glazing to levels 1–3 was replaced with clear glass, and external automated blinds were installed to control the solar load before it enters the building. The blinds allow for adjustment in two panels – allowing for glare to be avoided at desk level, and light to be reflected up to the ceiling at the same time. Each window has a manual override switch to give users direct control.

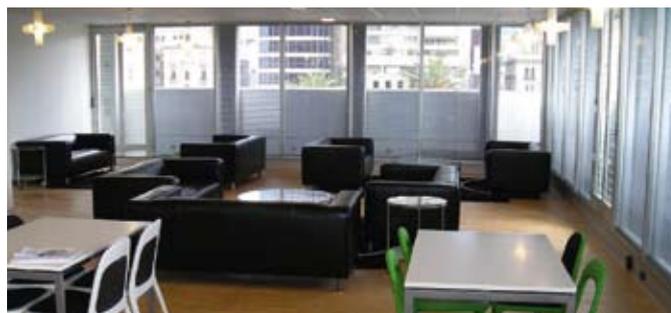
Figure 9: Naturally ventilated resource room (the high concrete upstand outside the perimeter of the top floor raises the question – why was full height glass originally installed?)

On Level 4 the large expanse of full height tinted glazing in the office area was replaced with an insulated 1.2m high spandrel panel and new low-e glass (except in the new naturally ventilated resource room where the existing glazing was retained and glass louvre doors added). This reduced heat losses/gains through the façade, improved comfort and increased daylight levels. The existing full height glazing to the ground level was retained as this had good shading (and the budget did not allow total replacement of this glazing).

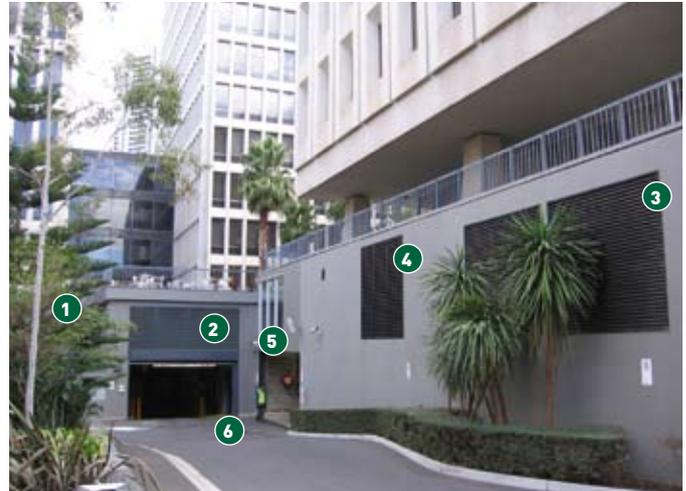
Figure 11: Relocated air intake

- 1: New supply air grilles cut into existing plenum on side and back wall (away from loading dock, car park entrance and service road)
- 2: Former supply air grille for car park blocked off. Plenum behind now supplies outside air to 55 St Andrews and to car park
- 3: Former air intake for main AHU converted into exhaust grille for new committee room AHU
- 4: Former window to lower ground stairwell blanked off, stair removed and space converted into plant room for new committee room AHU
- 5: Former air intake grill for lower ground A/C unit converted into window forming part of new supply air plenum.
- 6: Delivery dock and car park entrance

- Relocating the air intake for the building.
- Increasing outside air air to 40 per cent above the minimum code requirement
- Cleaning all the ductwork to remove dust accumulation from years of building use
- Installing high performance swirl air outlets to reduce draughts and improve air distribution to give more even temperature.
- Ducting the return air to the level 4 fan assisted VAV boxes to reduce ceiling void heat losses and gains.
- Creating a naturally ventilated winter garden at the northern end of level 4. This space is not air-conditioned (the existing ductwork is capped off) and is used as a meeting resource room, accessible to all building occupants.
- Improving the air-conditioning control strategies including a setpoint which is adjusted based on the outside air temperatures

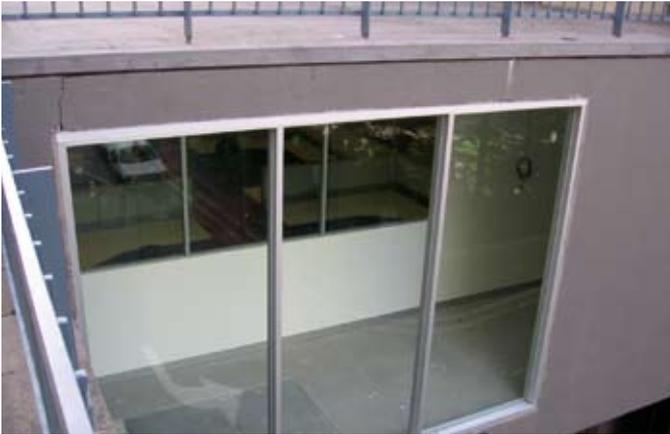
Figure 12: New supply air plenum behind new window to lower ground floor

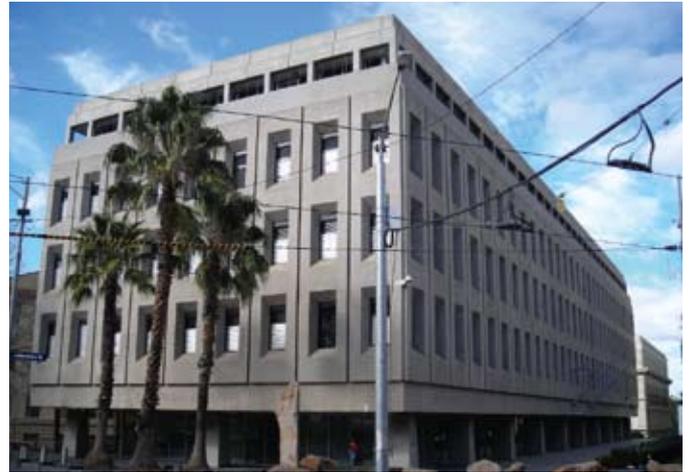
shows a 30% reduction in total electrical use in the building for base building and tenancy (excluding the chilled water which is supplied by the central plant). The chilled water consumption will be unchanged, as the original cooling capacity was retained to enable outside air quantities to be increased. The electricity data for 2007 includes the new data centre installed during the upgrade works.

Figure 16: Electricity profile for a typical week in August 2005 v 2007
